# **CERTS MICROGRID LABORATORY TEST BED**

Test Plan Section 7.0  
Validate Protection Settings and  
Initial Fault Testing

# **CERTS MICROGRID TEST REPORT**

*“Validate Protection Settings and Initial Fault Testing”*

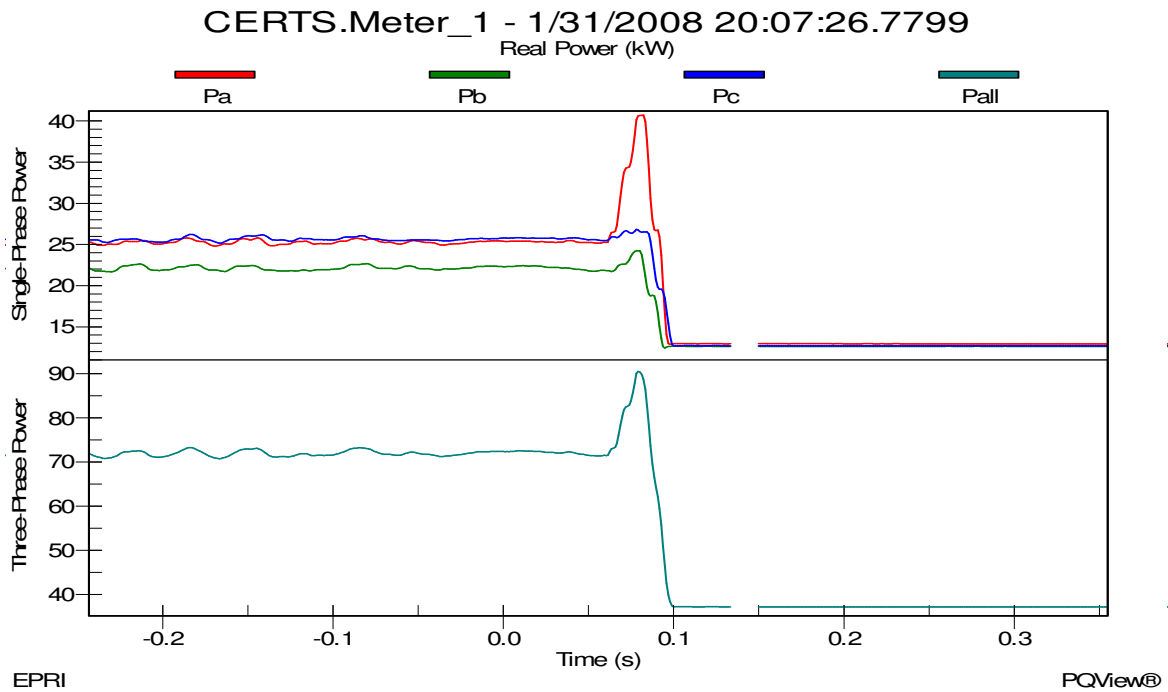
Figure 15a - Meter 1 power flow before/after the static switch opens, islanding the microgrid from the utility grid after a single phase-to-ground fault was applied to Zone 3.

After both Gen-sets A1 and A2 were running for a few minutes and supplying power to Load Banks 3 and 4, the test was started with a “Start” command from the EMS. As soon as the static switch closed and steady-state conditions established, the microgrid and Load Bank 6 were connected to the utility grid. Before the fault was applied the total power flow at Meter 1 was approximately 72.5kW shown in Figure 15a and approximately 35kW at Meter 2 shown in Figure 15b.

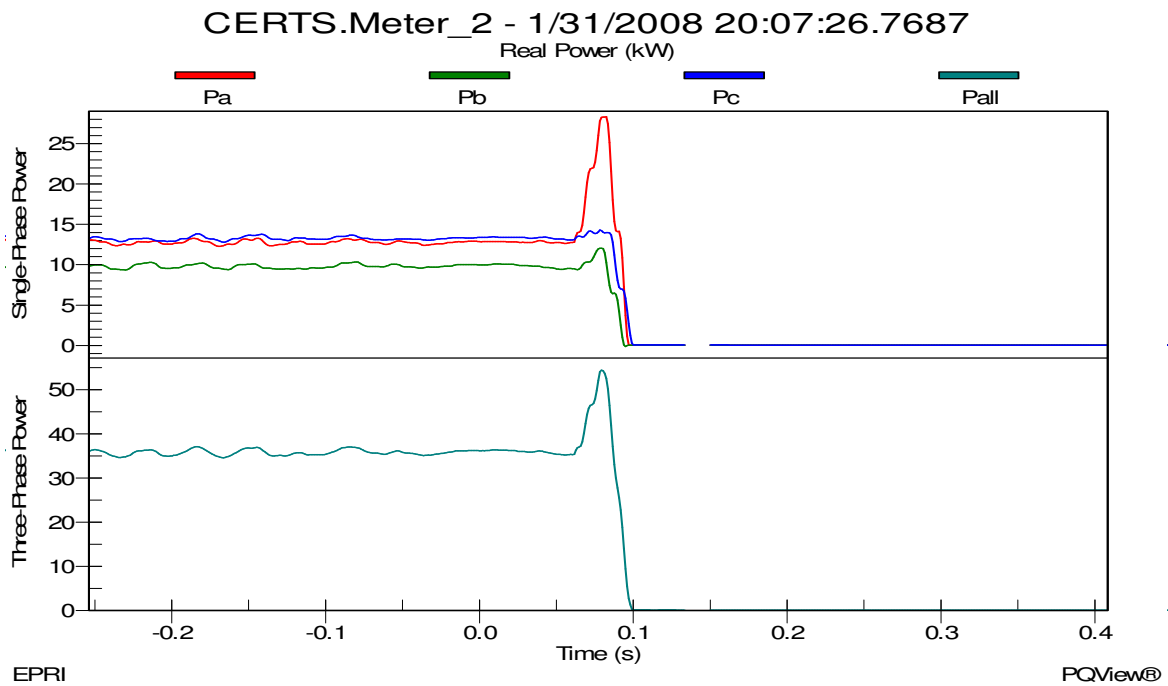
Figure 15b - Meter 2 power flow before/after the static switch opened, isolating the microgrid from the utility grid after a single phase-to-ground fault was applied to Zone 3.

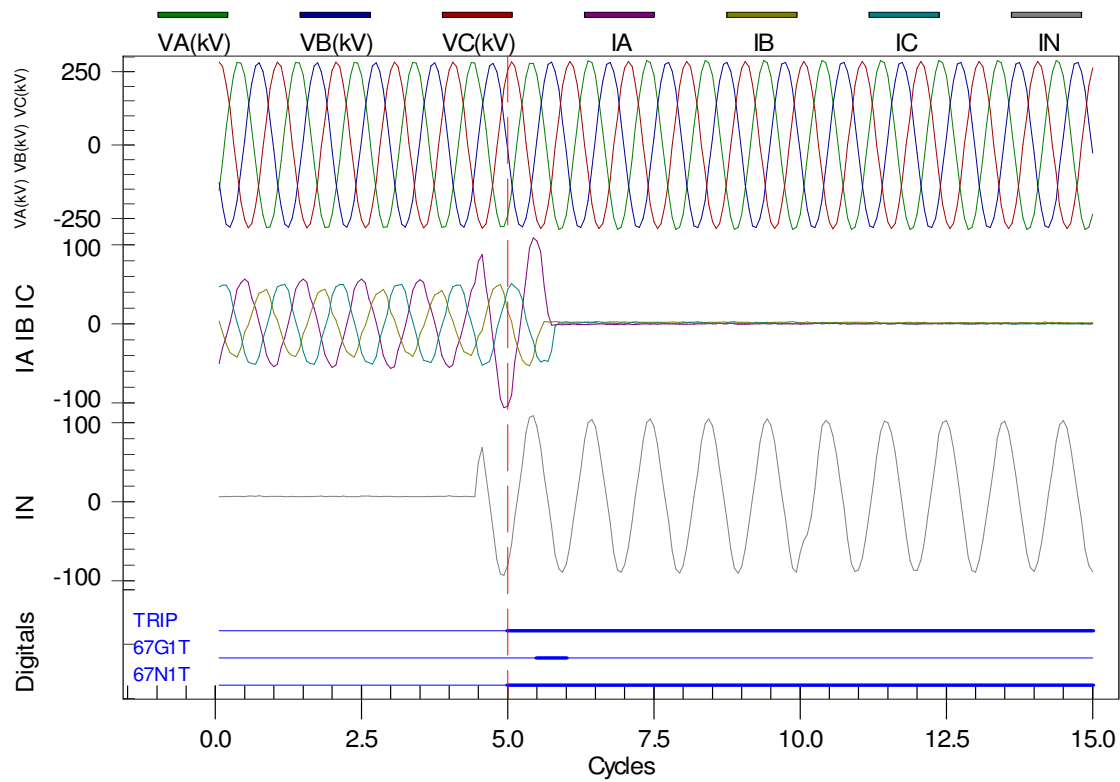
Figure 15c - Relay 2 (static switch) tripped after the single phase-to-ground fault was applied in Zone 3.

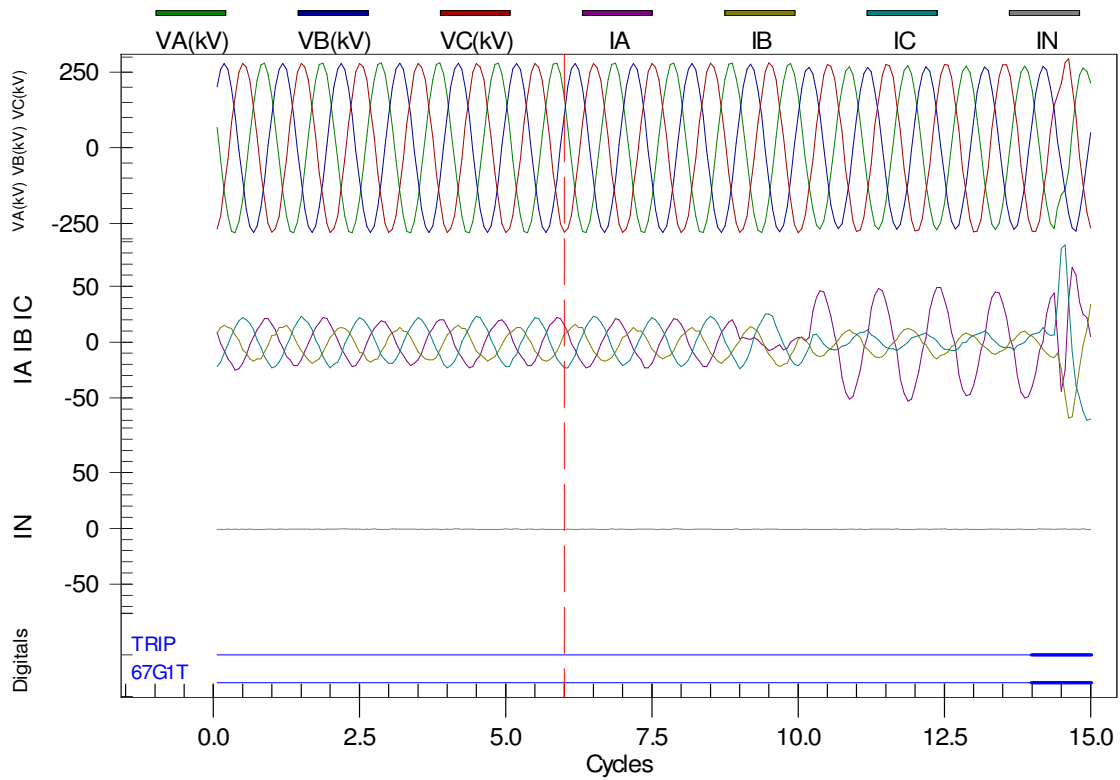
Relay 4 trips 0.07 seconds (~4.3 cycles) after the static switch opened due to a neutral over-current (67G1T), shown in Figure 15d, separating Zone 4 from the rest of the microgrid.

Figure 15d - Relay 4 (CB41) tripped after the single phase-to-ground fault was applied in Zone 3.

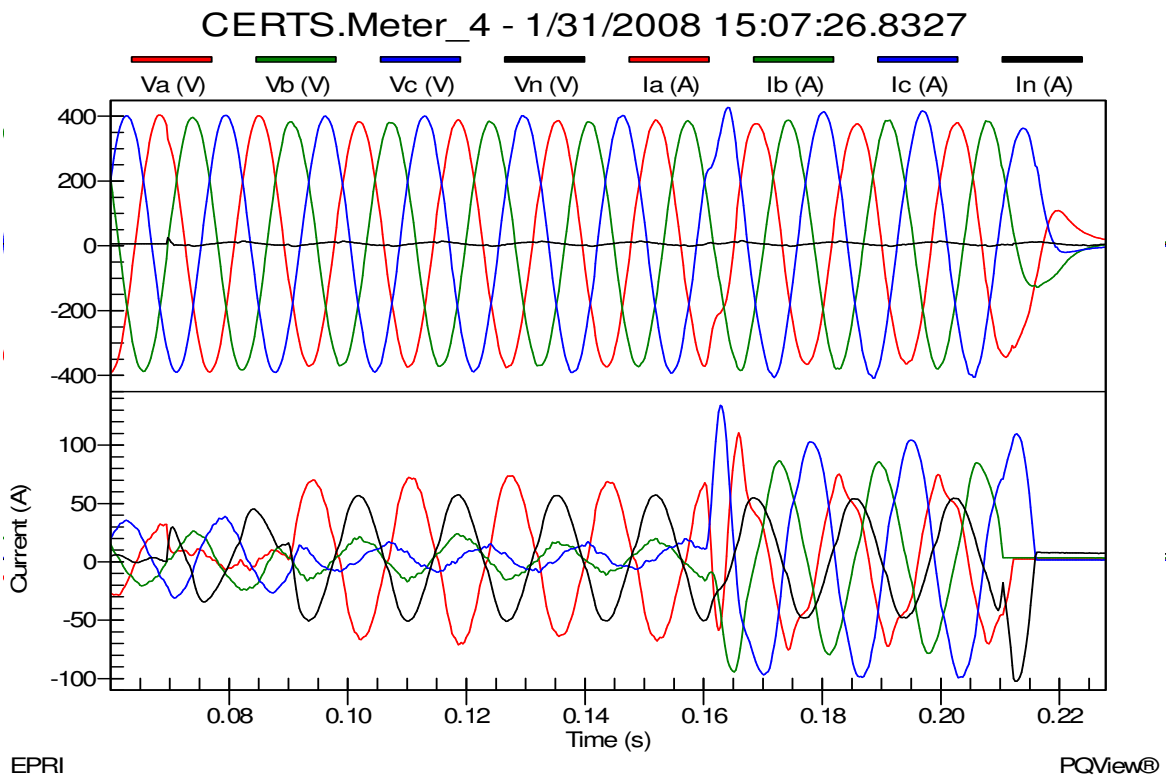
**Figure 15e - Meter 4 (CB41) voltage and current for a single phase-to-ground fault applied in Zone 3.**

A complex situation took place in Figures 15e, 15f and 15g. The fault was applied at 0.07 seconds which caused the static switch to open at 0.09 seconds. This was followed by a short period where both Gen-sets A1 and A2 were supporting the microgrid load, as well as the fault overload, shown in Figures 15f and 15g between 0.09 and 0.16 seconds. At 0.16 seconds Relay 4 commanded Gen-set A2 to shutdown and CB41 to open. Gen-set A2 first stopped delivering power to the microgrid, as seen by the sudden increase of current at Meter 4, Figure 15e, and Meter A1, Figure 15g. Even though Gen-set A2 stopped switching the inverter output, its interface transformer remained connected to the microgrid. This is evident by the continued current flow though Meter A2 after 0.16 seconds, Figure 15f, due to the Wye/Delta transformation, and also evident in the real power transferred from B and C phases to A phase at Meter A2 in Figure 15h. At 0.215 seconds CB41 opened reducing the current through CB41 to zero and denergizing Zone 4 of the microgrid.

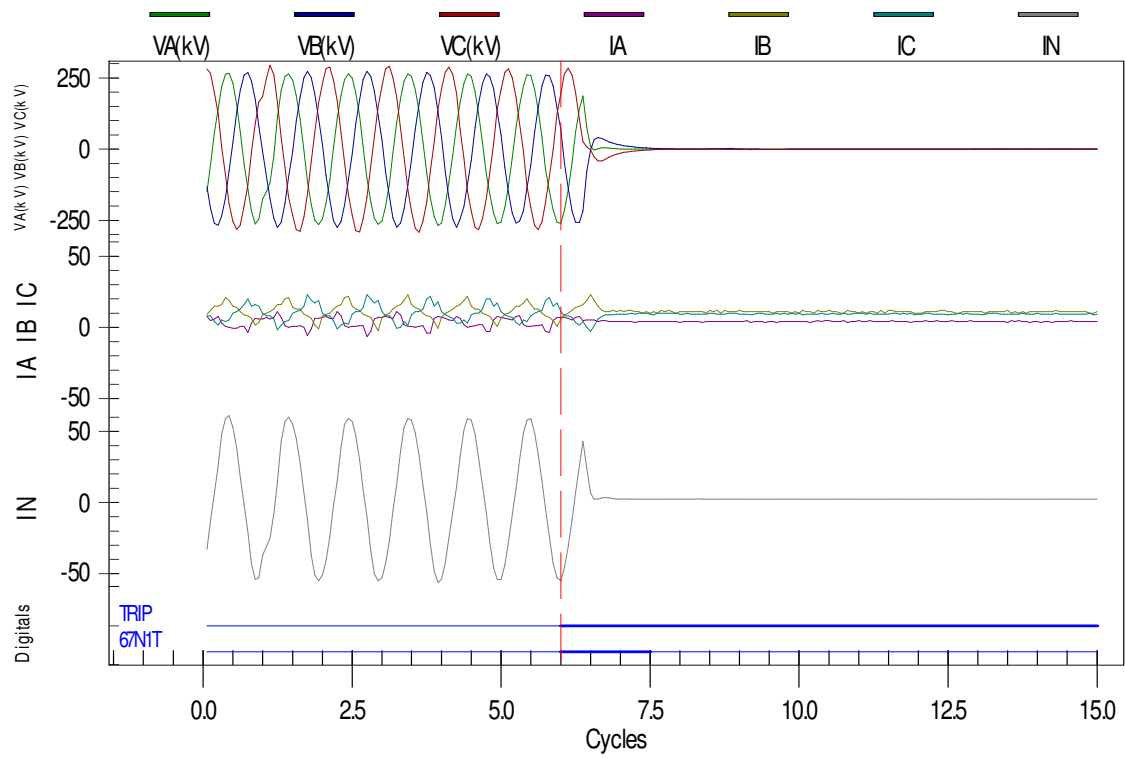
Relay 3 tripped Gen-setA1 and opened CB31 0.04 seconds (~2.3 cycles) after CB41 opened, due to ground over-current (67N1T), shown in Figure 15i, separating Zone 3 from the rest of the microgrid. In Figure 15j Gen-set A1 produced approximately 20kW before the single phase-to-ground fault was initiated and increased to approximately 48.5kW to satisfy Load Banks 3 and 4 along with generation from Gen-set A2 once the static switch opened. Output power for Gen-set A1 also increased to approximately 100kW for a brief period of time due to Gen-set A2 shutting down while the 40kW of Load Bank 3 and 4 remained connected.

Figure 15i - Relay 3 (CB31) tripped due to a ground over-current (67N1T) when the single phase-to-ground fault was initiated in Zone 3

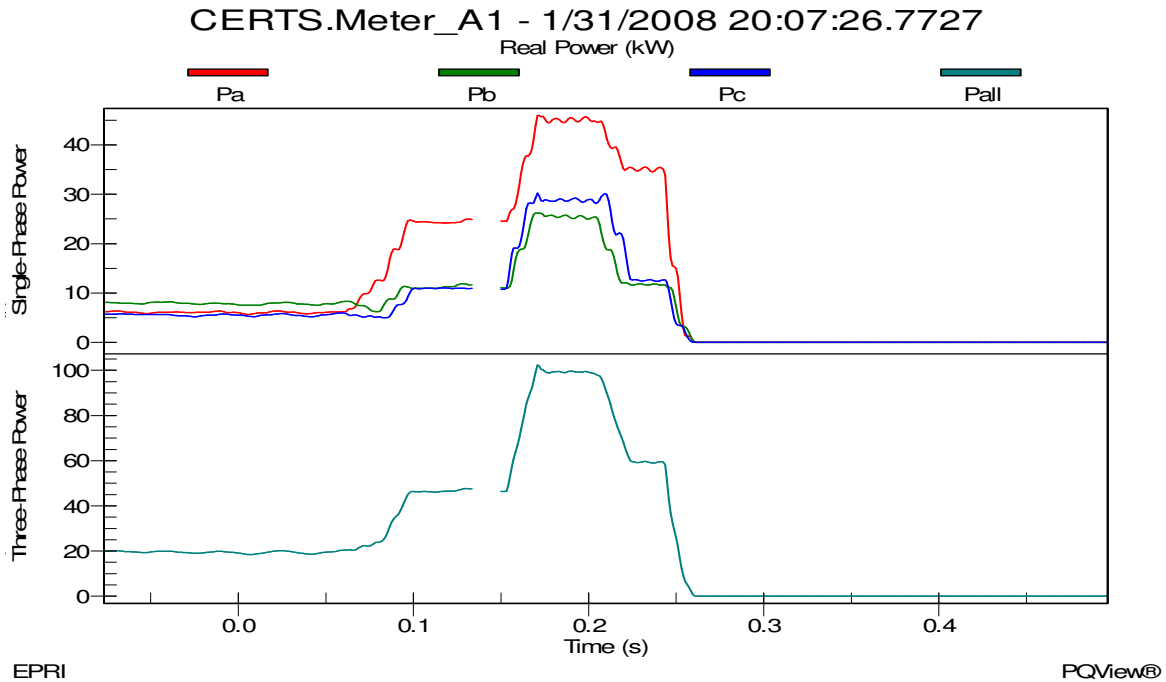
Figure 15j - Gen-set A1 output power before/after the static switch opened, when CB41 opens isolating Zone 4, and when Zone 3 is isolated from the rest of the microgrid.

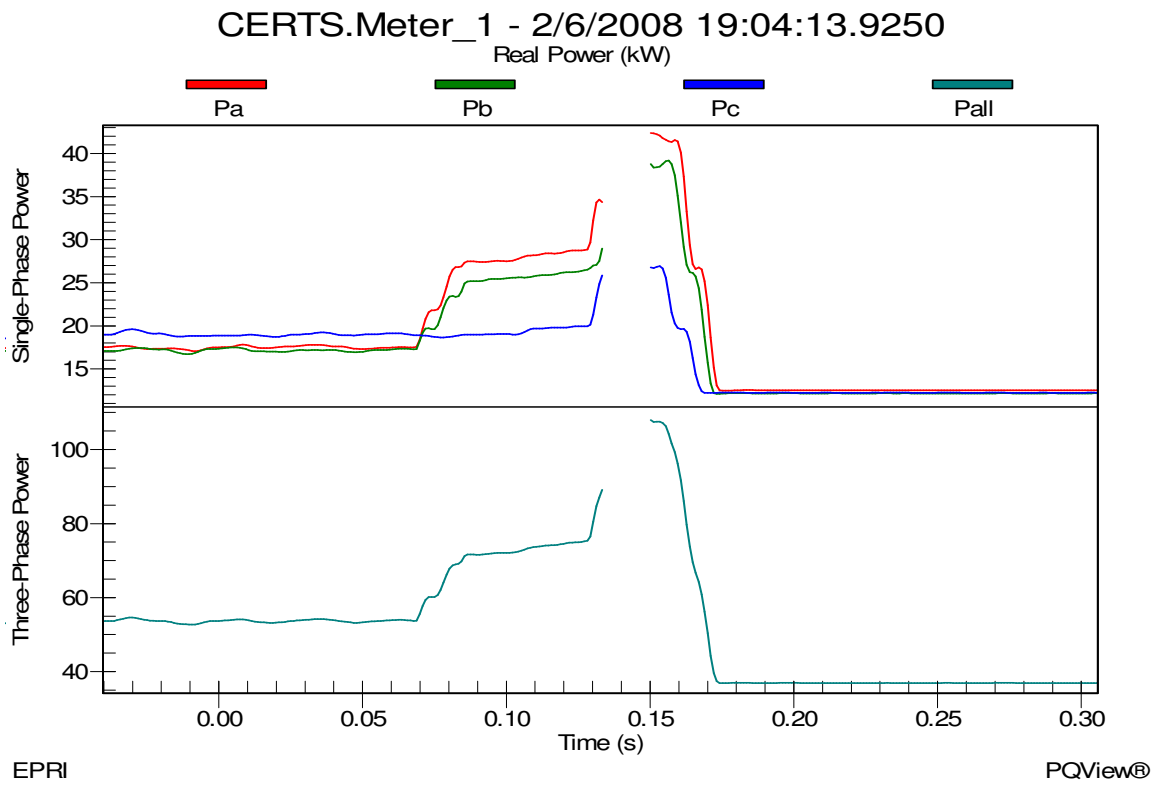
Figure 16a – Meter 1 power flow before/after the static switch opened, islanding the microgrid from the utility grid when a single phase-to-ground fault was applied in Zone 5.

After Gen-set B1 was running for a few minutes and supplying power to Load Bank 3, the test was started with a “Start” command from the EMS. As soon as the static switch closed and steady-state conditions established, the microgrid and Load Bank 6 were connected to the utility grid with total power flow at Meter 1 being approximately 54kW, shown in Figure 16a, and approximately 17.5kW at Meter 2 shown in Figure 16b before the fault was applied.

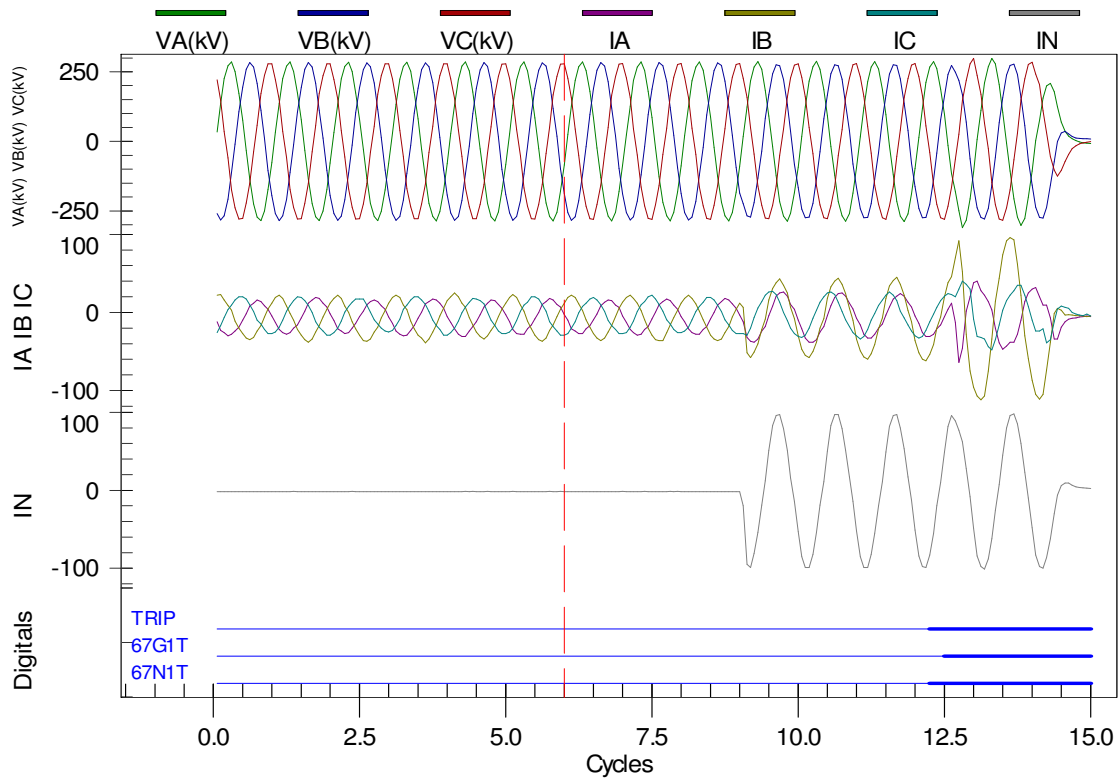
Figure 16c – Relay 5 (CB51) tripped due to ground over-current (67N1T) after the single phase-to-ground fault was initiated in Zone 5.

Using the DAS Load Control program, a single phase-to-ground overload fault on B-phase was set for 10 seconds and then initiated. The protection coordination for this event appears to be different than expected. After the fault is initiated Relay 5 first trips shutting down Gen-set B1 and opening CB51, Figure 16c. The Gen-set stops switching the inverter output, however its transformer contactor and CB51 remains closed for a brief period of time, Figure 16d. After the Gen-set stops switching the fault current at the static switch becomes large enough to cause Relay 2 to trip on negative sequence (67Q1T), Figure 16e. Relay 5 tripped first approximately 0.07 seconds (~4.2 cycles) separating Zone 5 from the rest of the microgrid. The static switch opened 0.03 seconds (~1.75 cycles) after Relay 5 tripped, islanding the microgrid from the utility.

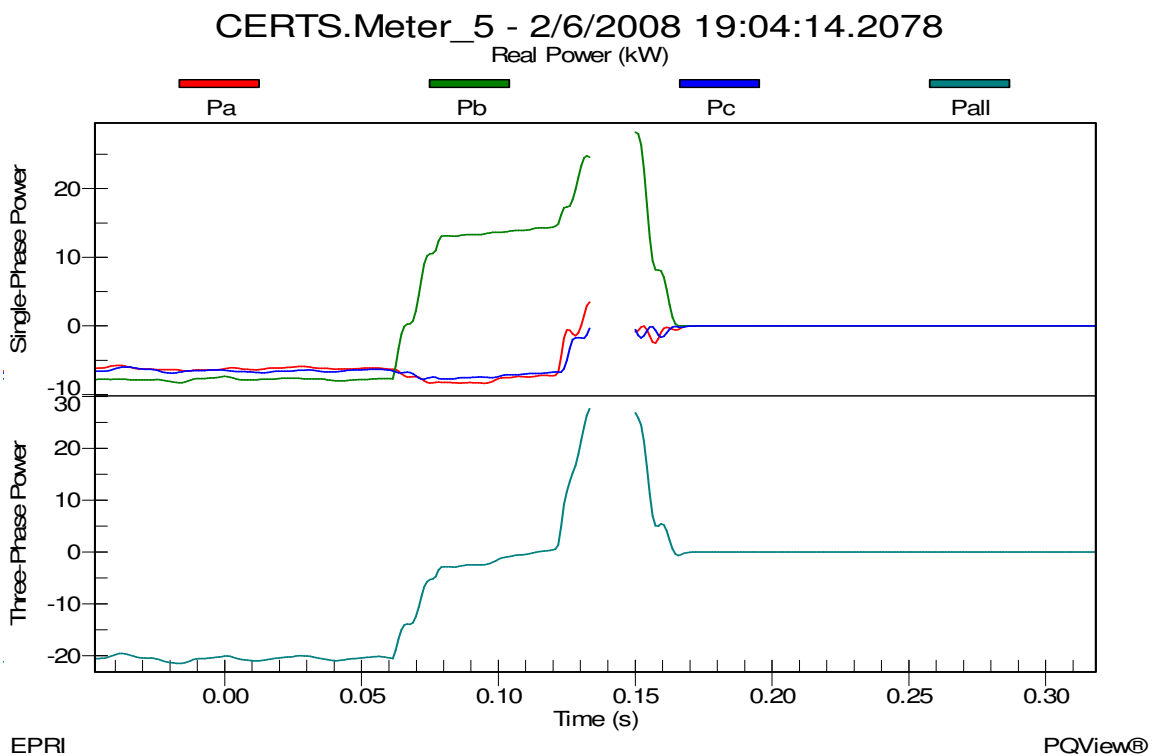
Figure 16d – Meter 5 power flow for a single phase-to-ground fault applied in Zone 5.

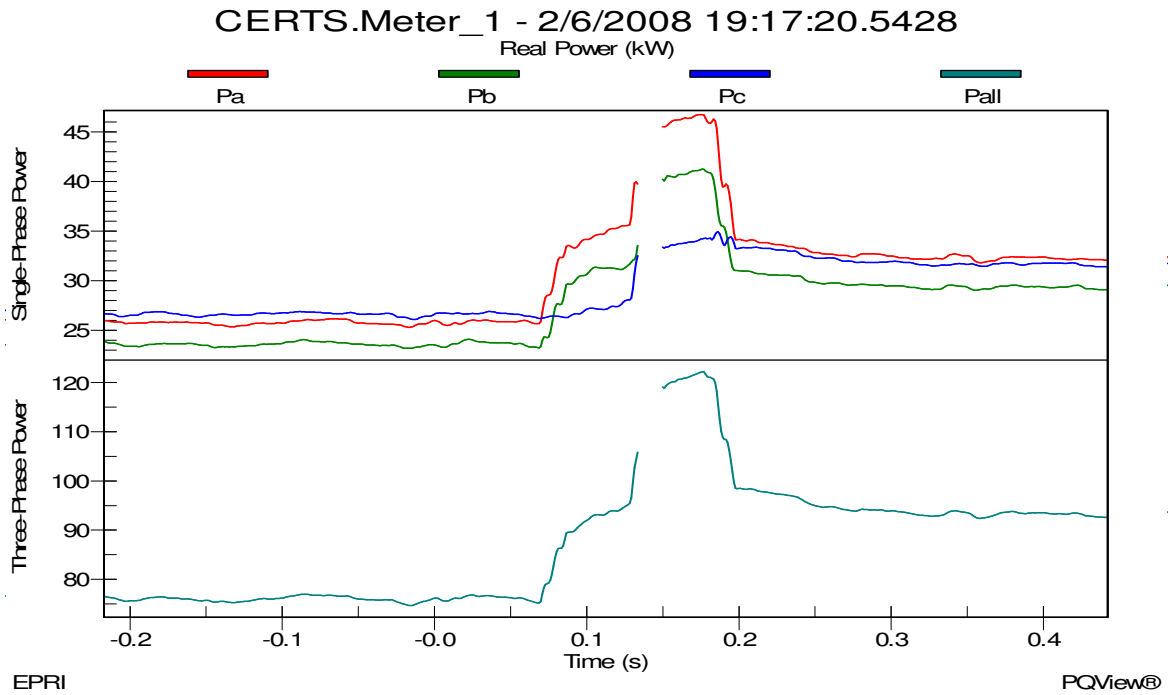
Figure 17a – Meter 1 power flow for a single phase-to-ground fault applied in Zone 5.

After both Gen-sets A1 and B1 were running for a few minutes and supplying power to Load Banks 3 and 4, the test was started with a “Start” command from the EMS. As soon as the static switch closed and steady-state conditions established, the microgrid and Load Bank 6 were connected to the utility grid with the total power flow at Meter 1 being approximately 75kW, shown in Figure 17a, and approximately 40kW at Meter 2, shown in Figure 17b. Gen-sets A1 and B1 were producing between 17 to 18kW each, shown in Figures 17c and 17d, before the overload fault was applied.

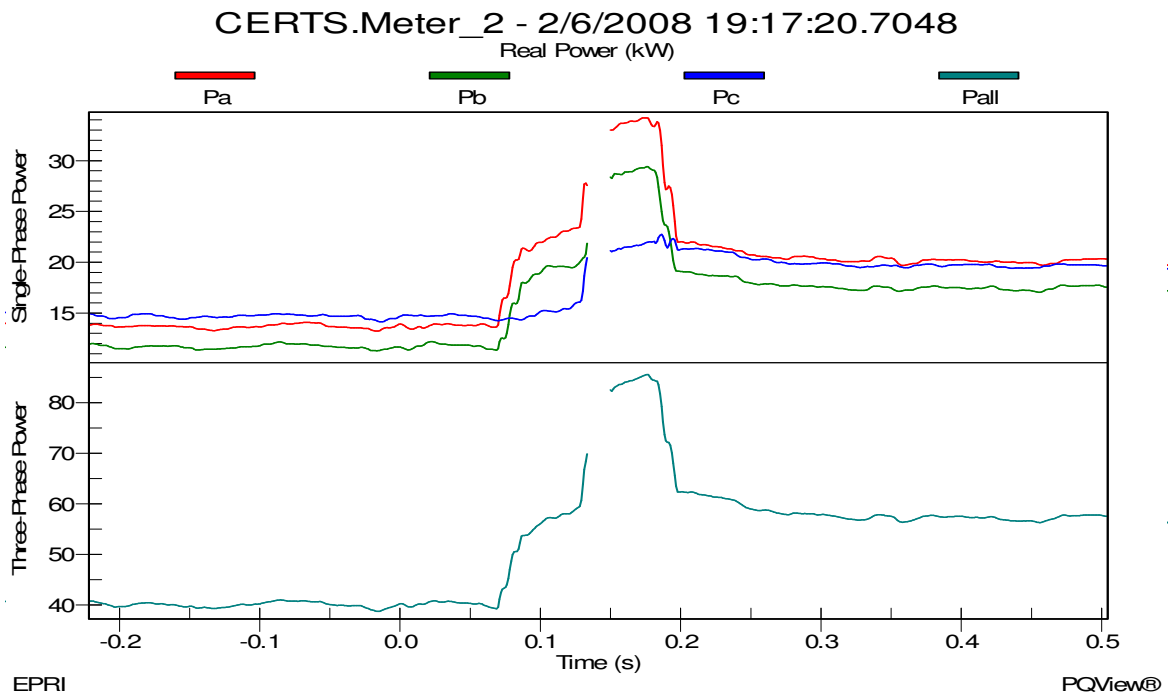
Figure 17b Meter 2 power flow for a single phase-to-ground fault applied in Zone 5.

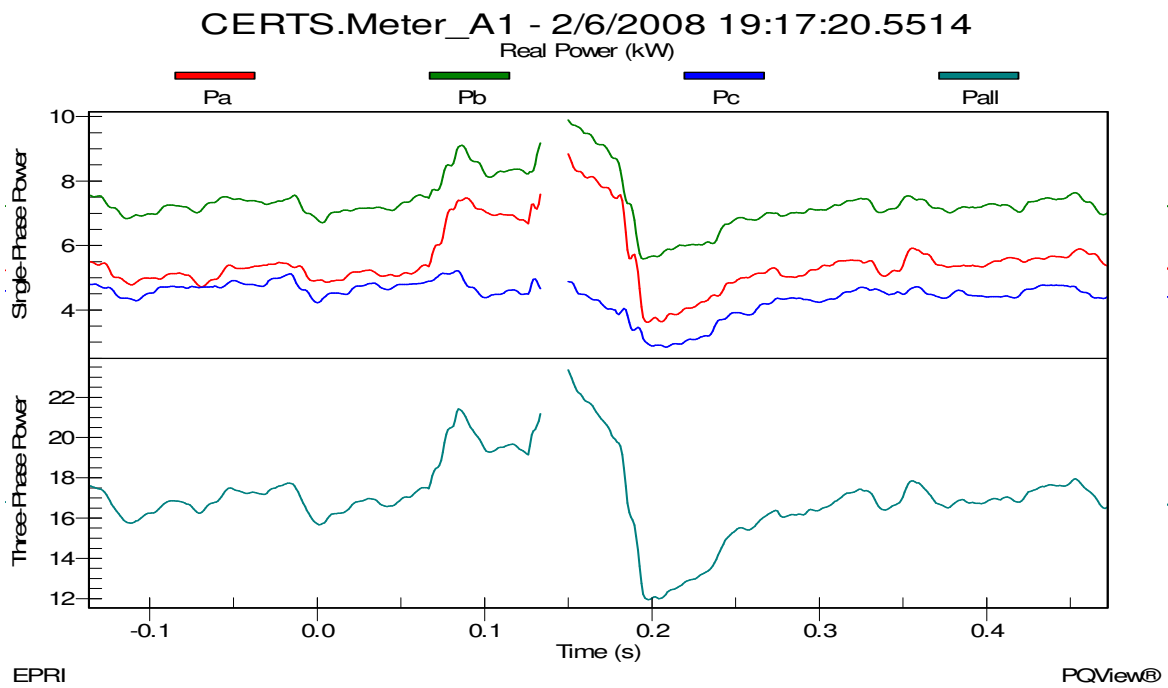
Figure 17c - Power produced by Gen-set A1 before/after a B-phase phase-to-ground fault in Zone 5.

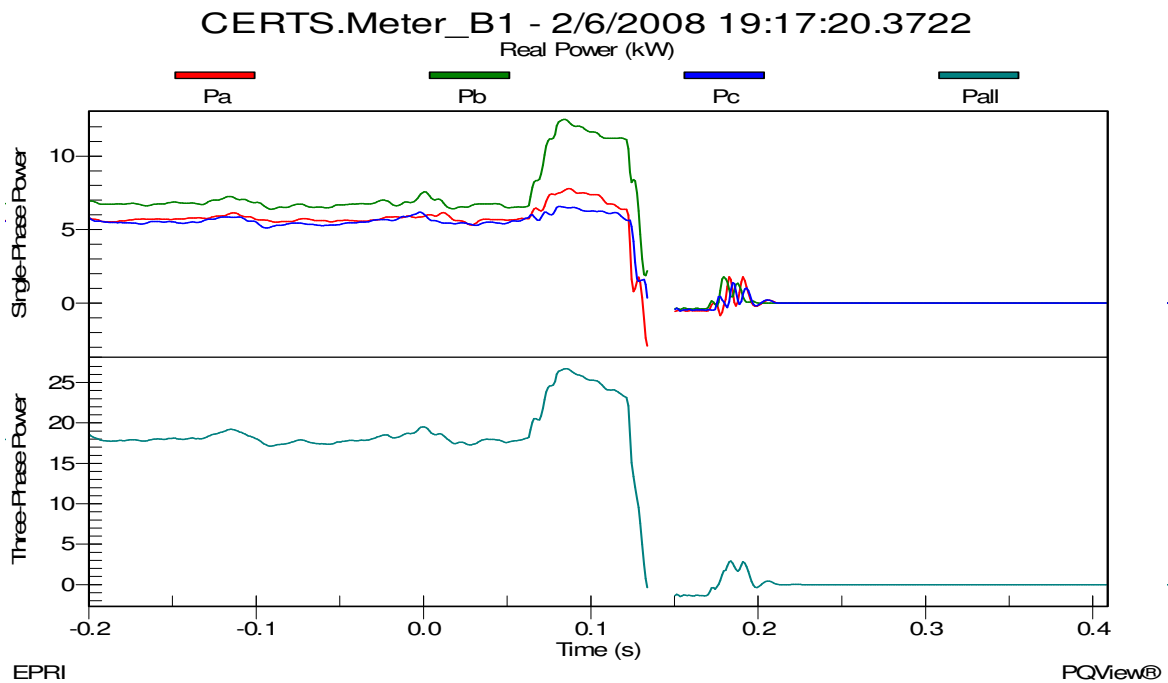
Figure 17d - Power produced by Gen-set A2 before/after a B-phase phase-to-ground fault in Zone 5

The protection coordination for this event appears to be different than expected but similar to the previous test. After the fault was initiated, Relay 5 tripped on ground over-current (67N1T), shutting down Gen-set B1 and opening CB51, Figures 17d and 17e. The Gen-set stopped switching the inverter output; however, its transformer contactor and CB51 remained closed for a brief period of time, Figure 17f. Once CB51 cleared 0.06 seconds (3.8 cycles) later the fault was removed and Zone 5 was de-energized, Figure 17g. The static switch and remaining zones of the microgrid remained online and connected.

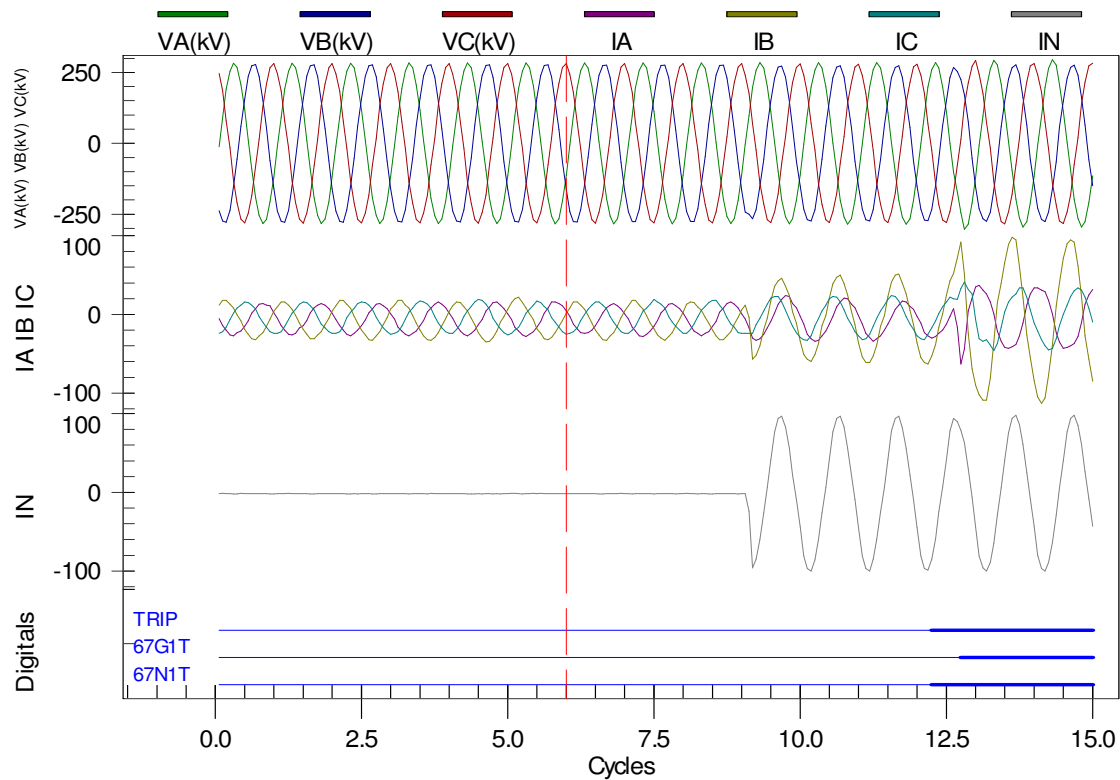
Figure17e - Relay 5 (CB51) tripped due to a ground over-current (67N1) after the single phase-to-ground fault was initiated in Zone 5.

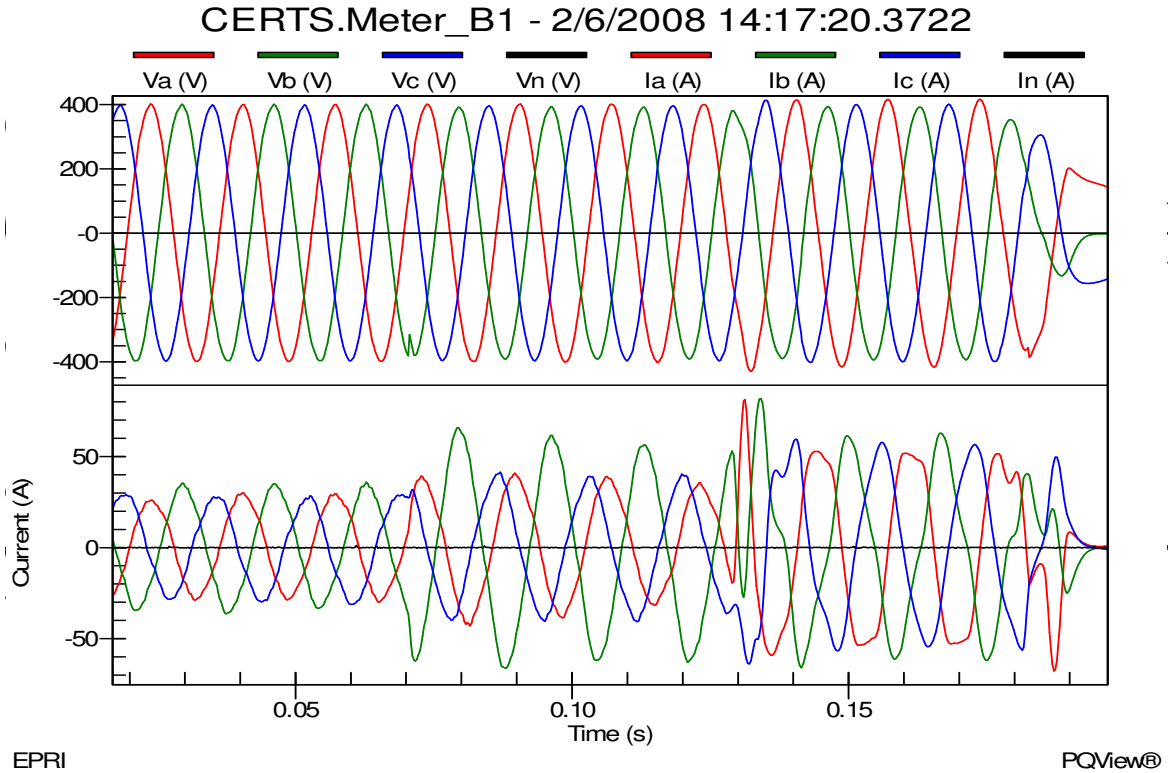
Figure17f – Meter B1 voltage and current for a single phase-to-ground fault applied in Zone 5.

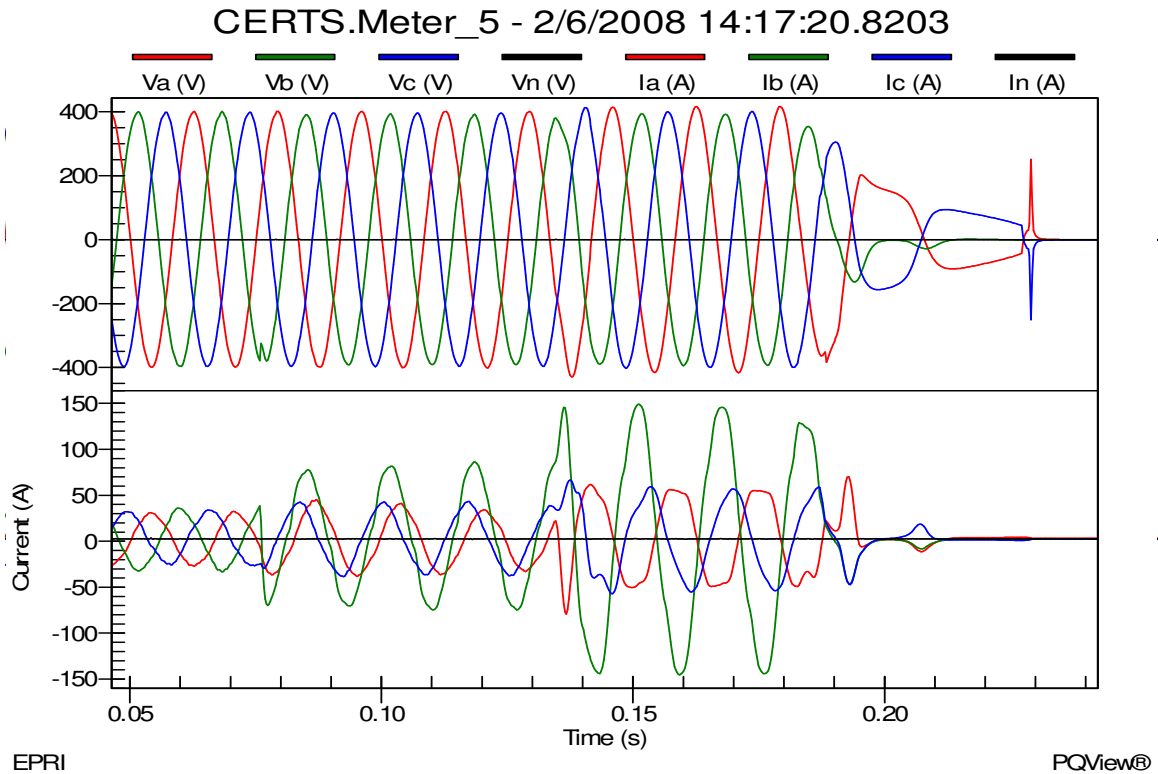
**Figure17g- Meter 5 (CB51) voltage and current for a single phase-to-ground fault applied in Zone 5**

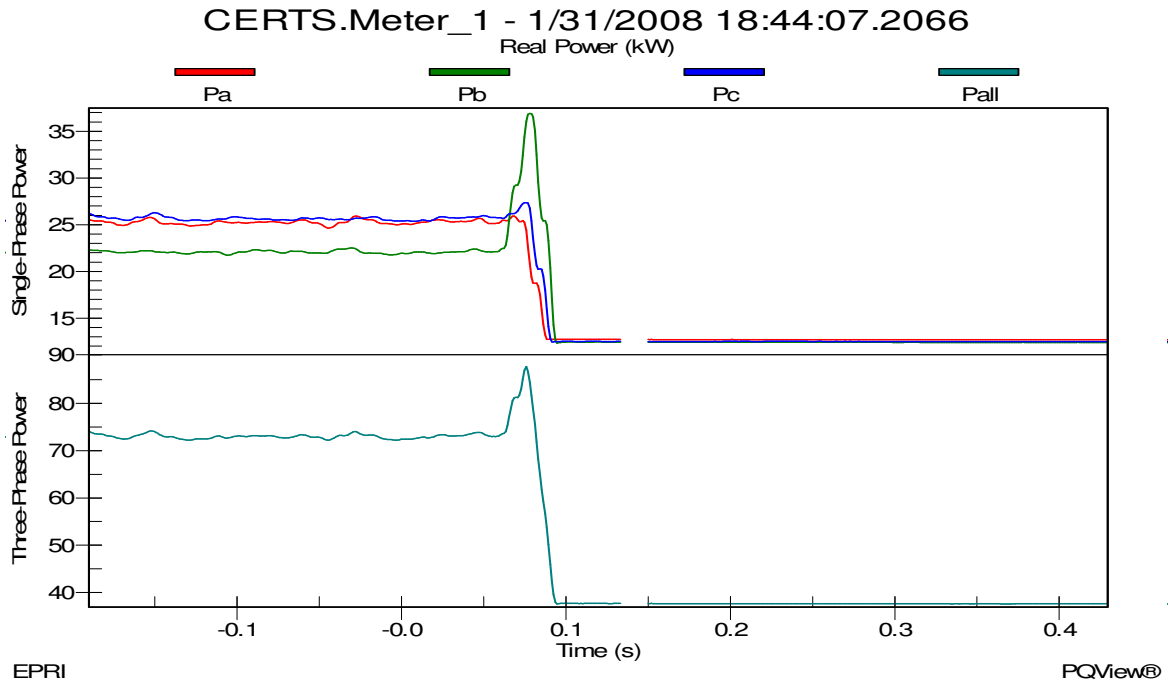
soon as the static switch closed and steady-state conditions established, the microgrid and Load Bank 6 were connected to the utility grid with the total power flow at Meter 1 being approximately 74kW, shown in Figure 18a, and approximately 36kW at Meter 2, shown in Figure 18b. Gen-sets A1 and A2 were producing about 20kW each, shown in Figures 18c and 18d before the fault was applied after 0 seconds.

**Figure 18a Meter 1 power flow before/after the static switch opened, islanding the microgrid from the utility grid when a single phase-to-ground fault was applied in Zone 4.**

Gen-set A2 stopped switching approximately 0.008 seconds (~0.5 cycles) after Relay 4 tripped; however, its transformer contactor and CB41 remained closed for a short period. In Figures 18a and 18b power flow through Meter 1 was approximately 37.5kW, supplying only the load in Load Bank 6 from the utility. Load Bank 3 was supplied power from Gen-set A1, within the islanded microgrid, with output power raised from approximately 20kW to about 36kW to meet the load demand, Figure 18c. CB31 and CB51 remained closed throughout the entire test.

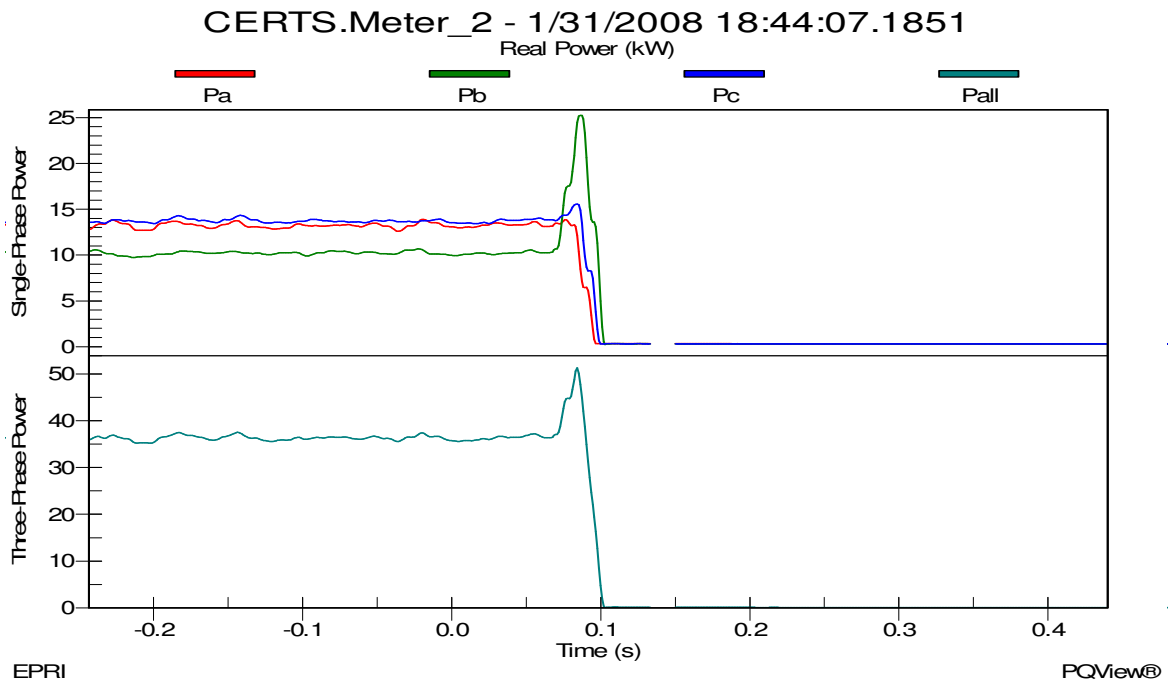
Figure 18b Meter 2 power flow before/after the static switch opened, islanding the microgrid from the utility grid when a single phase-to-ground fault was applied in Zone 4.

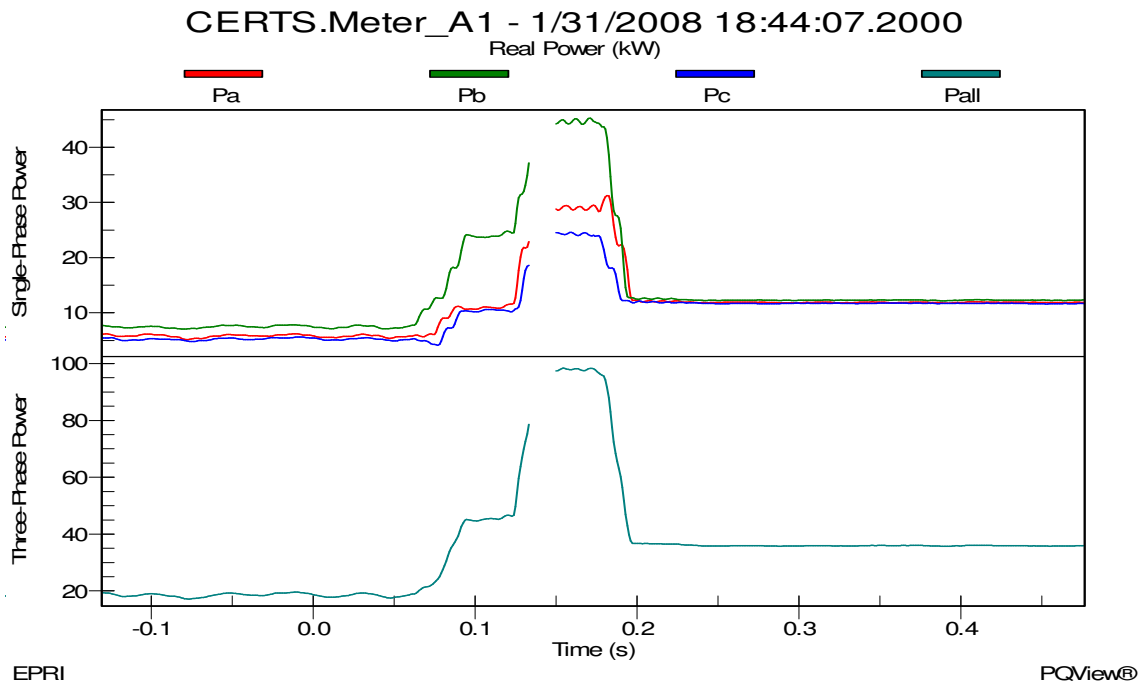
Figure 18c - Power produced by Gen-set A1 before/after the static switch and CB41 opened when a B-phase-to-ground fault was applied in Zone 4.

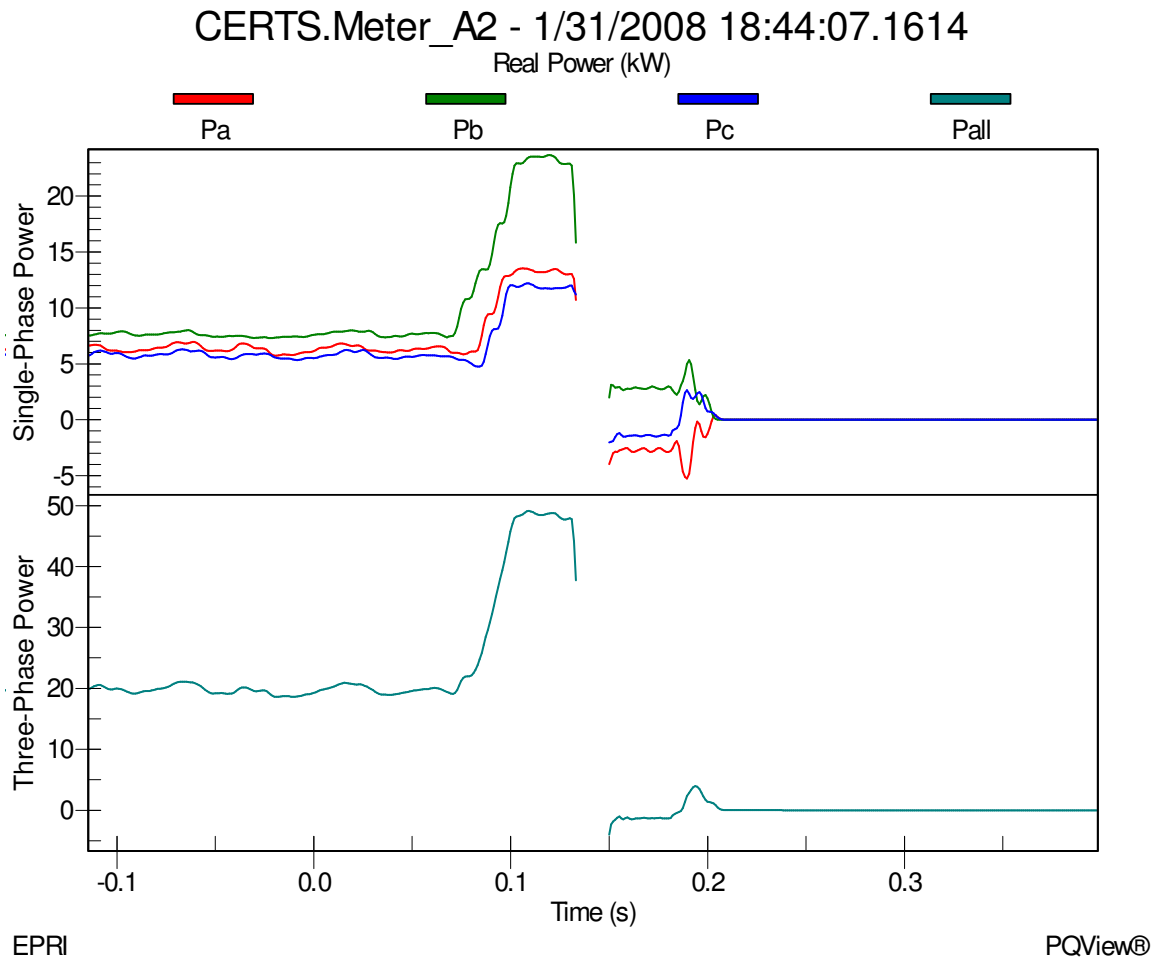
**Figure 18d - Power produced by Gen-set A2 before/after the static switch and CB41 opened when a B-phase-to-ground fault was applied in Zone 4.**

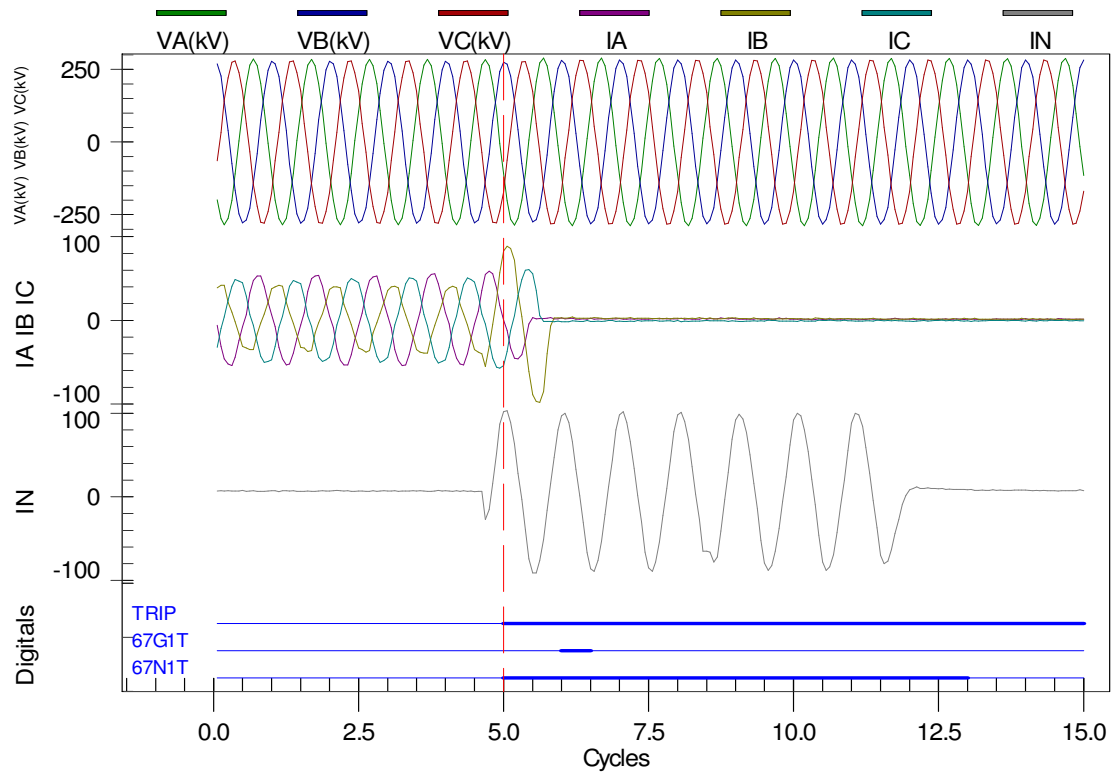
Using the DAS Load Control program, the single phase-to-ground fault on B-phase was set for 10 seconds and then initiated. The static switch tripped in approximately 0.007 seconds (~0.4 cycles) from a ground over-current (67N1T), shown in Figure 18e, islanding the microgrid from the rest of the utility grid. Relay 4 tripped after approximately 0.058 seconds (~3.5 cycles) on a ground over-current (67N1T) signal, isolating Zone 4 from the rest of the microgrid, shown in Figure 18f.

**Figure 18e - Relay 2 (static switch) tripped due to a ground over-current (67N1T) when the single phase-to-ground fault is applied in Zone 4.**

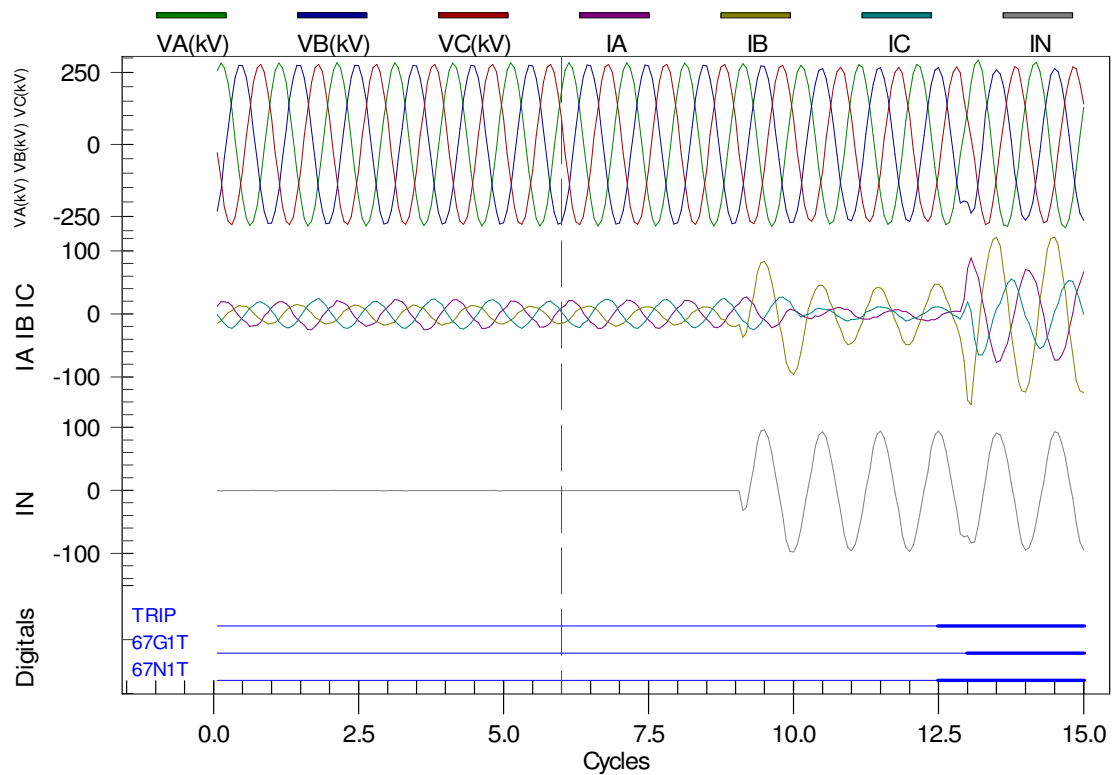
**Figure 18f – Relay 4 (CB41) tripped due to a ground over-current (67N1T) when the single phase-to-ground fault was initiated in Zone 4**
